The Home Inspectors

PROPERTY INSPECTED:

2048 Huran Dr.

May 9, 2011

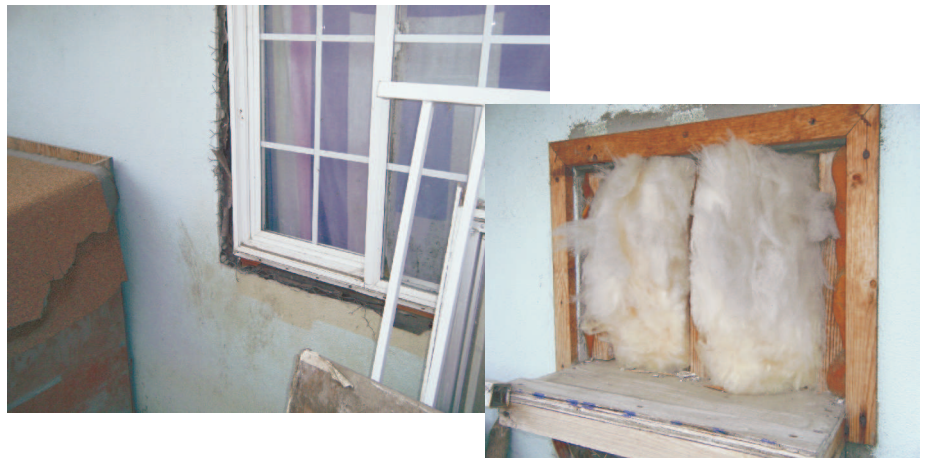
There is miscellaneous patched stucco (around windows)

and missing stucco at a window and where something was removed at the left ([attention needed](#)).

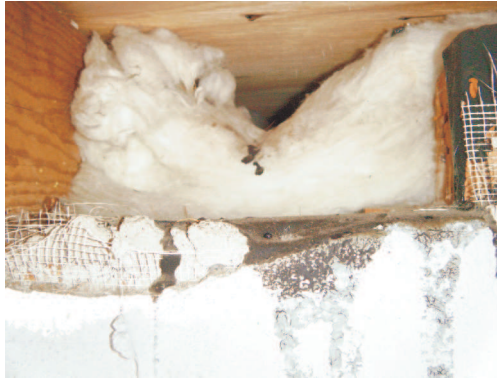
There are unsealed openings into the ceiling cavity (and a birds nest in one) along the right eaves ([attention needed](#)).

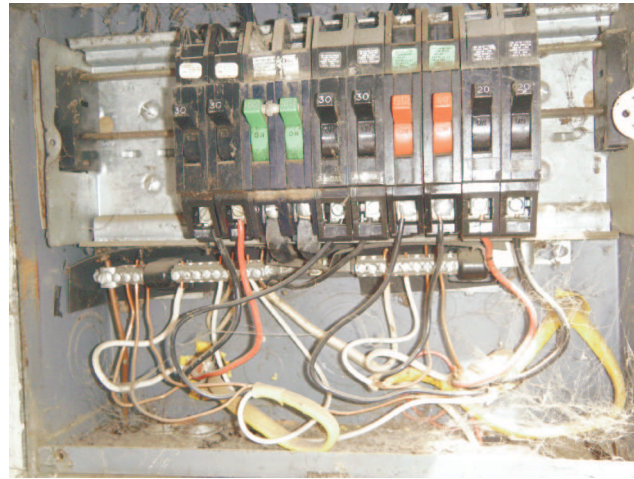
1. The breaker-to-wire size does not appear properly matched at 2-30amp breakers. There are also a pair of 30amp breakers which appeared to be for 220v but missing a handle tie and there are unprotected electrical cables exiting the panel through open knockouts.

Recommendation: For further evaluation of the electrical system and repairs as needed contact a licensed electrician.

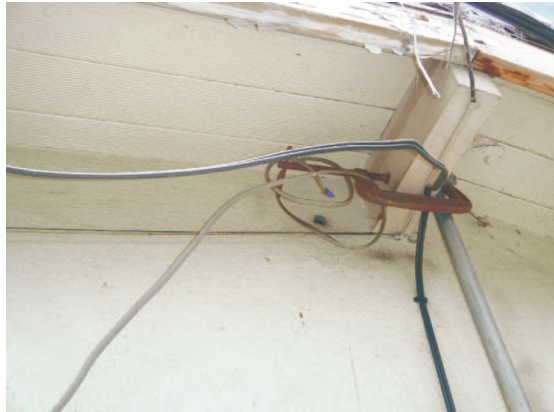
2. There are miscellaneous non weather tight lights, outlets and switches at the exterior as well as an open junction box and

Romex cable terminated at a taped off end at the rear exterior.

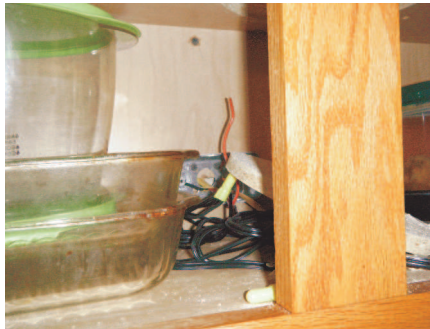
3. The microwave oven power cord is attached somewhere not determined over the cabinet/ceiling.

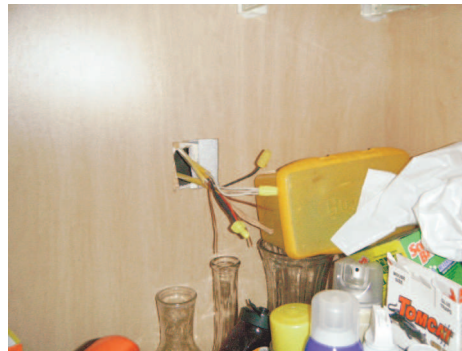
4. There is exposed spliced wiring in the cabinet over the kitchen sink

and in the cabinet under the kitchen sink.

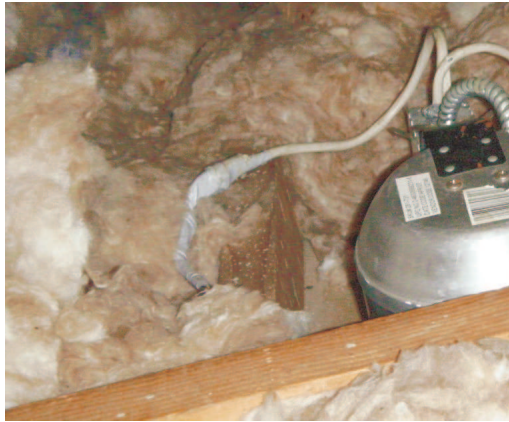
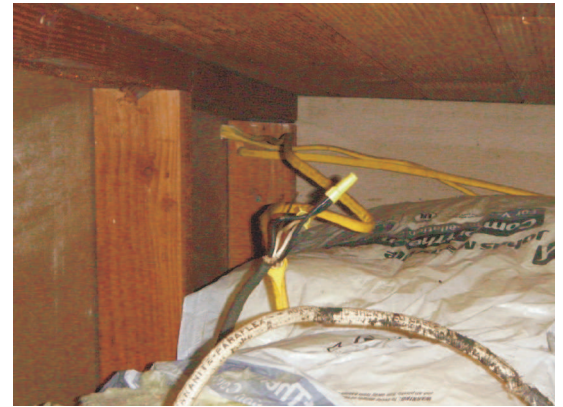
8. There is exposed spliced wiring in the attic.

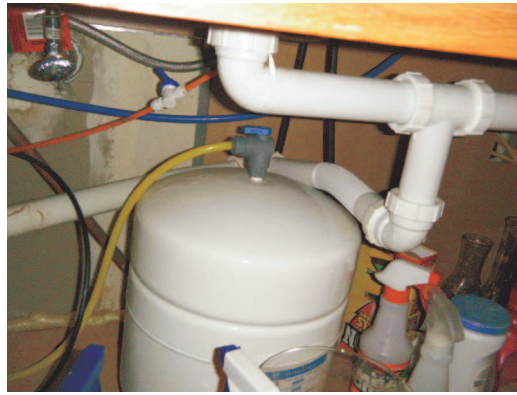
1. The addition bathroom sink and the kitchen sink both have improper drains using flex piping (prone to clog) and with no P-trap at the drain which can lead to venting of sewer gas (attention needed).
