# WOOD DESTROYING PESTS AND ORGANISMS INSPECTION REPORT

Building No. 2048	Street HURAN DRIVE	City SAN JOSE	Zip 95122	Date of Inspection 5/10/11	Number of Pages 6
----------------------	-----------------------	------------------	--------------	-------------------------------	----------------------

GENERAL DESCRIPTION: OCCUPIED/ONE STORY/SINGLE FAMILY RESIDENCE/WOOD FRAME/STUCCO/WOOD SIDING	Inspection Tag Posted: WATER HEATER <hr/> Other Tags Posted:
--	--

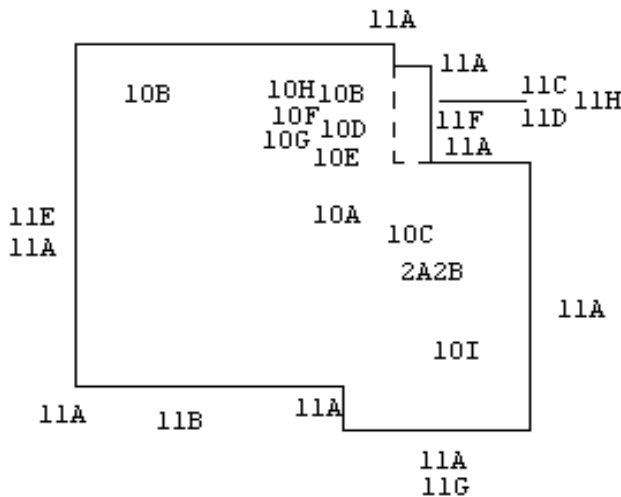
**Diagram Not To Scale**

An inspection has been made of the structure(s) shown on the diagram in accordance with the Structural Pest Control Act. Detached porches, detached steps, detached decks and any other structures not on the diagram were not inspected.
